Harrison Township, New Jersey

Preliminary Investigation (Resolution 233 - 2015)

January 22, 2016

Study by,

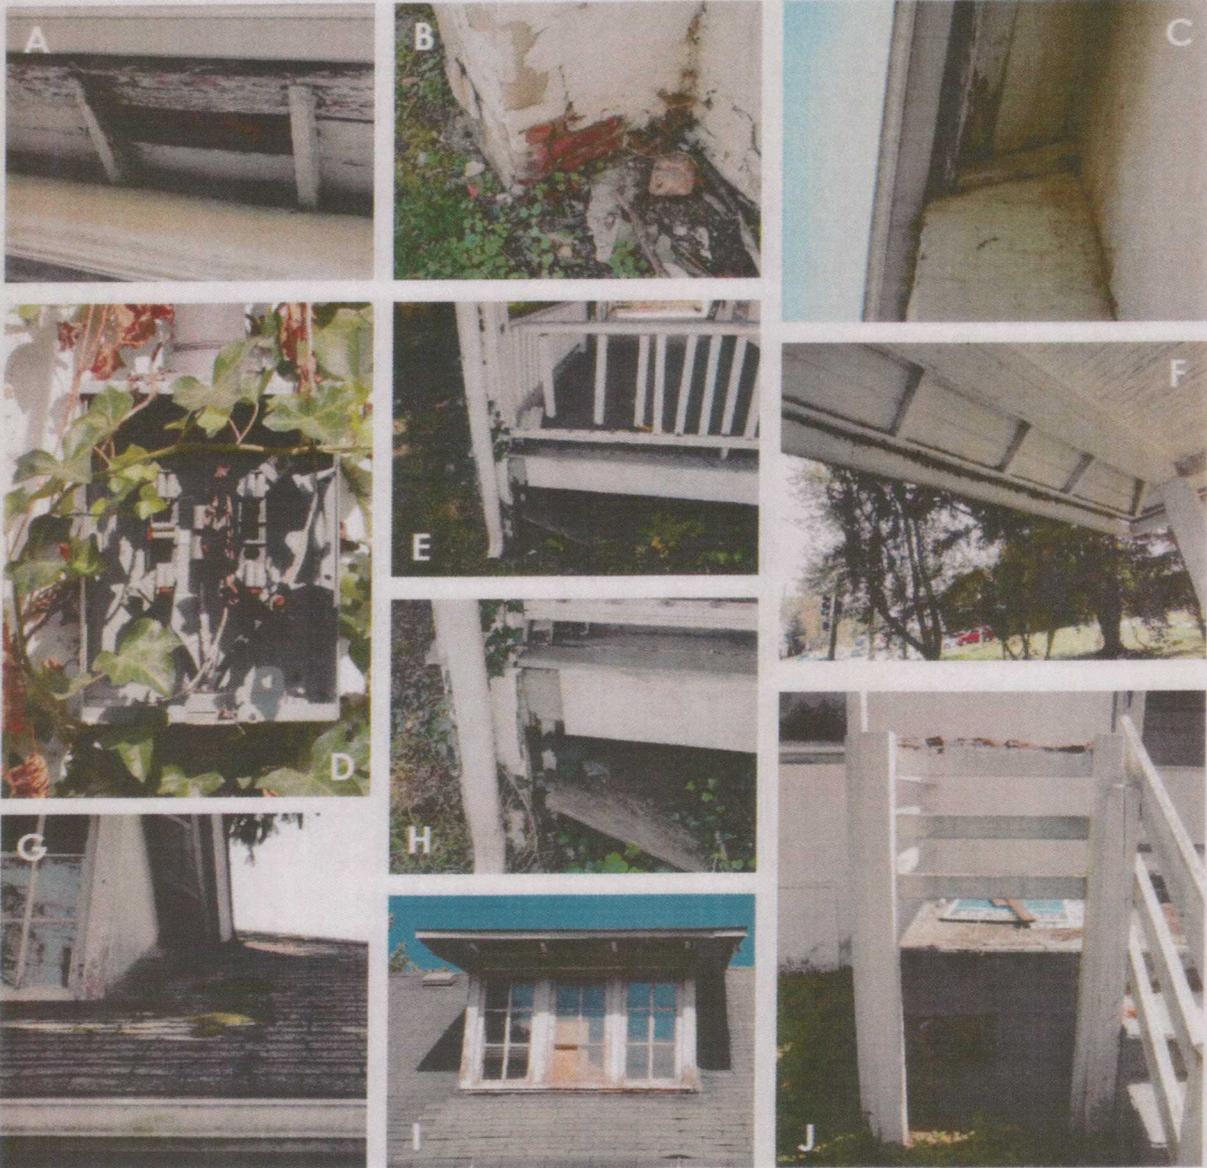
Figure 3. Photographs of Structural Issues at Block 64, Lot 5

Substandard Structure: The structure on Block 64, Lot 5 is in a state of disrepair that has caused the building to qualify as substandard. As illustrated in the photographs shown in Figure 3, several issues related to this deterioration are evident:

1. Deterioration and rotting at the underside of the roof. (Photos A, C, & F)
2. Damage to the roof exterior as evidenced by organic growth on the roof shingles. (Photo G)
3. Deterioration and damage to masonry at the buildings foundation. (Photo B)
4. Organic growth surrounding exterior electrical systems. (Photo D)
5. Structural damage to the underside of the porch and porch railings. (Photos E, H, & J)
6. Deterioration to structural integrity of the gable. (Photo I)

These issues combined indicate the building is substandard, unsafe, and dilapidated and is not conducive to wholesome living or working conditions.

Criteria "A" applies to Block 64, Lot 5 due to substandard conditions of the structure and site configuration based on information obtained through a survey of the property and the building's exterior and interior conducted by Group Melvin Design on October 1, 2013.

This report concludes that the property and building survey found evidence that the principal structure on Block 64, Lot 5 is in a state of disrepair that results in the site being a detriment to the health, safety, morals and welfare of the community and possesses characteristics as to be conducive to unwholesome living or working conditions.

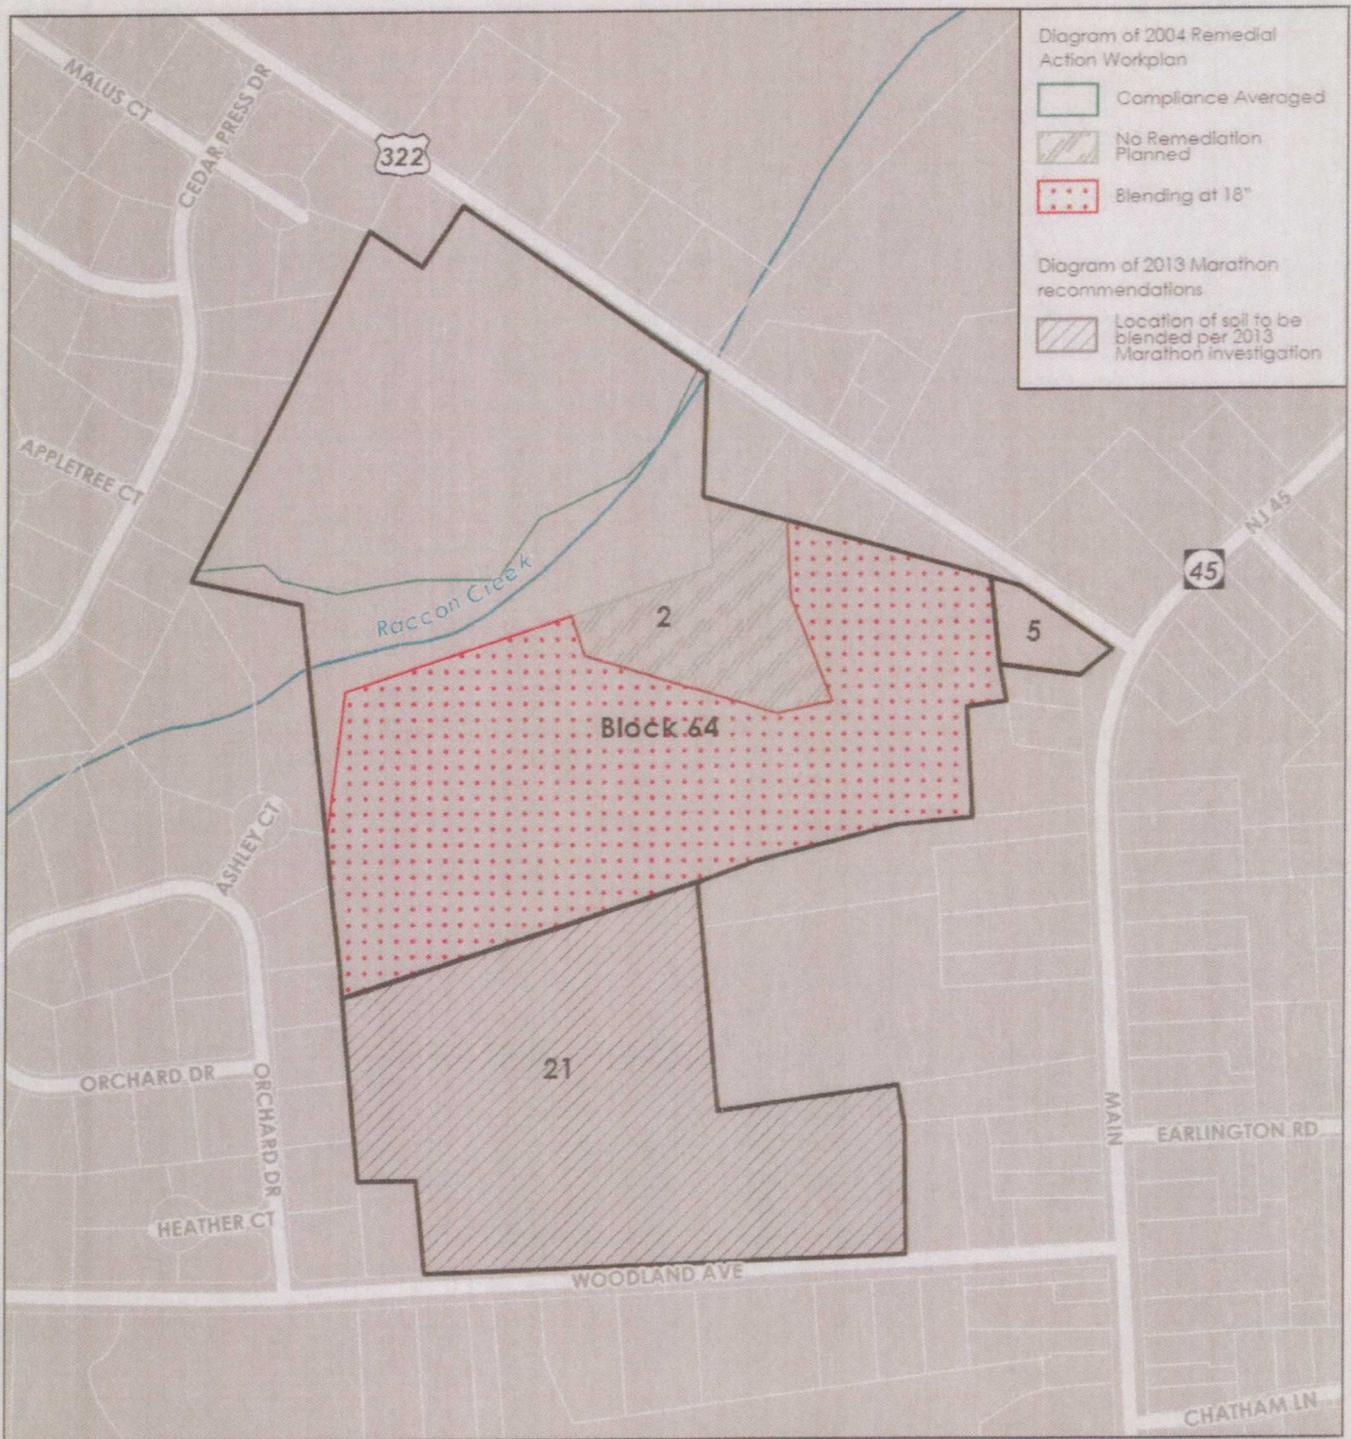
Figure 4. Diagram of 2004 Remediation Action Workplan and recommendations of 2013 Marathon Investigation

NOTE: Construction of the Route 322 Mullica Hill Bypass is not reflected on this map.

ERI's Remedial Action Workplan (RAW) prepared in 2004 recommended blending contaminated surface soils (in the 0-6 inch interval) with clean soils below, at the same site, between the 6-18 inch interval. Marathon's analysis of the 2004 RAW agreed that soil blending was the most feasible solution to address the contamination, however, Marathon disagreed with ERI's methodology of combining surface soils with deeper subsurface soils for the following reasons:

Item 1: "For soil blending to be effective and cost efficient, there needs to be a source of clean soil that is free of dieldrin. While ERI's investigation revealed the impacted soils was limited to the top 6-inch interval, it is likely that the soils on the Holtzhauser Property in the 6 to 12-inch interval still contain dieldrin, just at concentrations below the NJDEP's Residential Direct Contact Soil Remediation Standards ("RDCSRS"). Soil blending projects often fail because the "clean" soil still has dieldrin at concentrations below the RDCSRS. In these instances, a much greater quantity of clean soil is required to achieve the targeted RDCSRS than blending with soil that does not contain any detectable concentrations of dieldrin".

Marathon recommended that the only feasible option to complete soil blending on the Holtzhauser Property was to use clean topsoil obtained from the Gardiner Property. This strategy was recommended because it "eliminates the uncertainty described in Item 1 above because we have sufficient analytical data on Gardiner Property topsoil to know that it is free of dieldrin". Additionally, blending topsoil from these two properties "will preserve a natural resource by creating a blended soil that is free of dieldrin while still containing enough organic matter to support vegetation". Marathon also noted that this strategy would be consistent with Harrison Township's Topsoil Protection Ordinance, § 192-35 which states that:

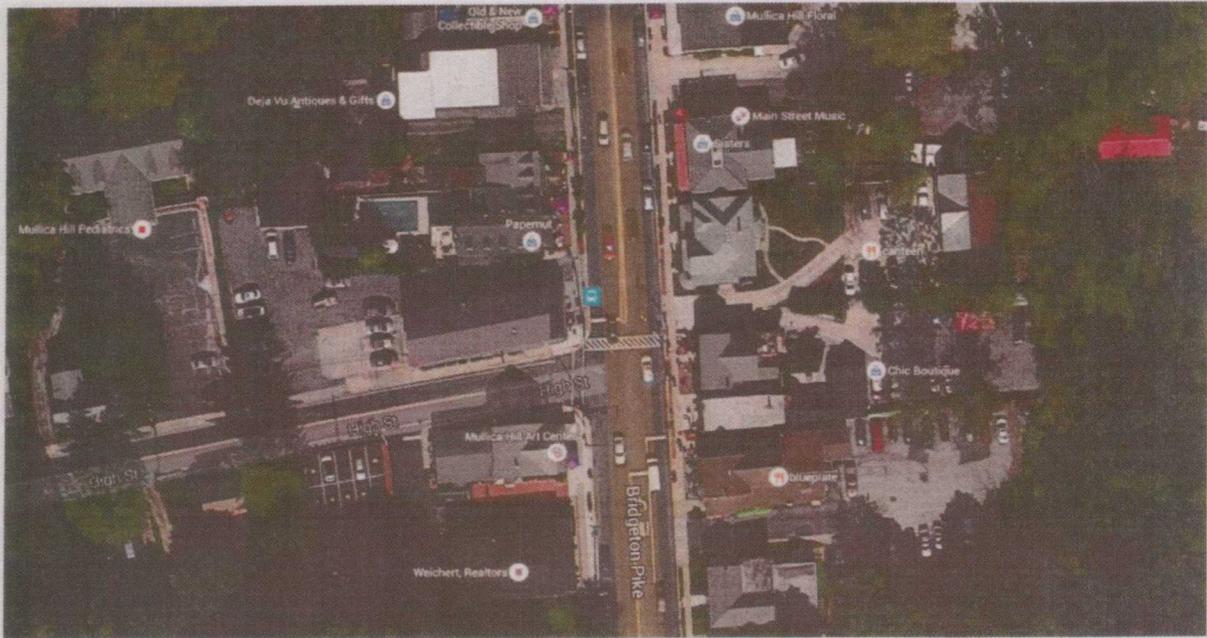
Figure 7. Obsolete Layout and Design of Downtown Parcels

Cluster of shops and restaurants along Main Street and High Street. The density of businesses, age of the structures, and limited parking circulation has created negative market effects, including reduced property values.

- A narrow roadway along Main Street, creating traffic-control issues, as well as limited on-street parking options for local businesses.
- Narrow set-backs limit structure retrofitting due to small amounts of available land area and high construction costs.
- Limited parking areas for current consumer needs.
- Frequent curb cuts along the Main Street create unsafe pedestrian conditions.

These layout and design challenges do not support current resident and customer needs, and will continue to cause barriers to new investment and smart growth development.

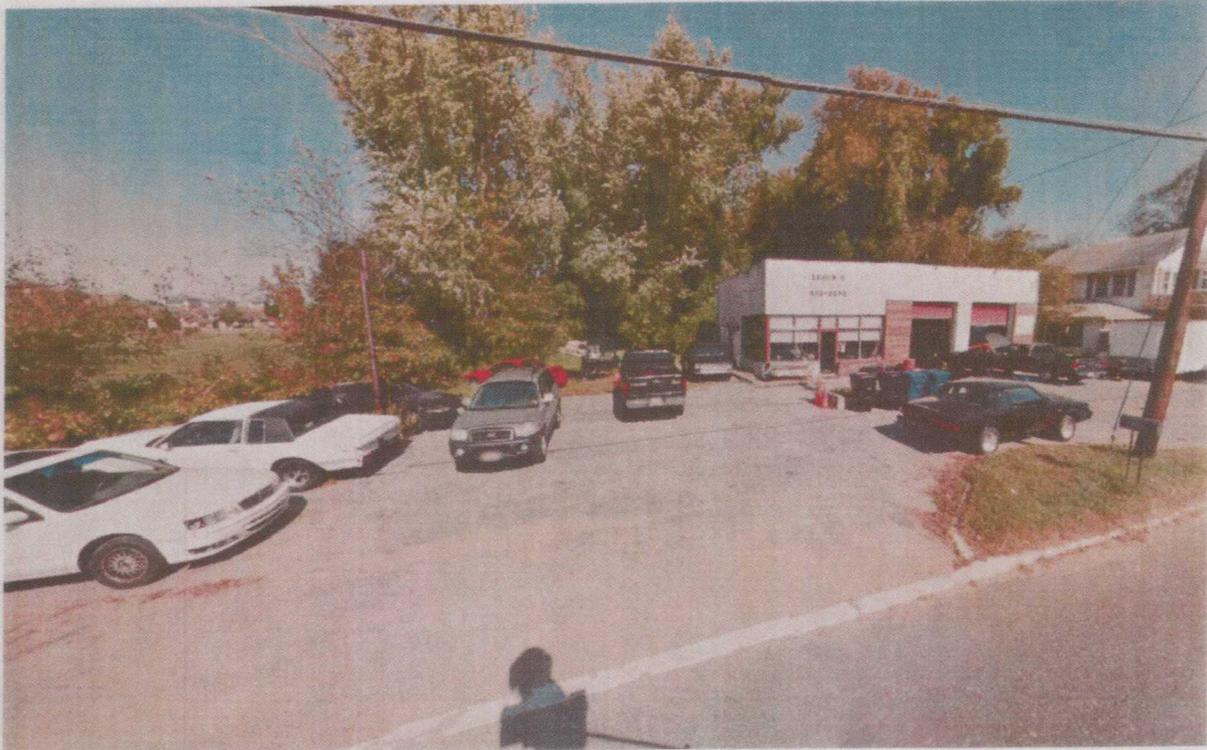
Figure 10. Street View of Shooks Car Care (structure A), Lot 18

The narrow setbacks of along Bridgeton Pike create an unsafe condition, as vehicles parked in front of the structure have to back out into the busy roadway. This creates a public safety hazard for those attempting to enter and exit the Lot, and has possible adverse effects to the vehicular traffic flow along the roadway.

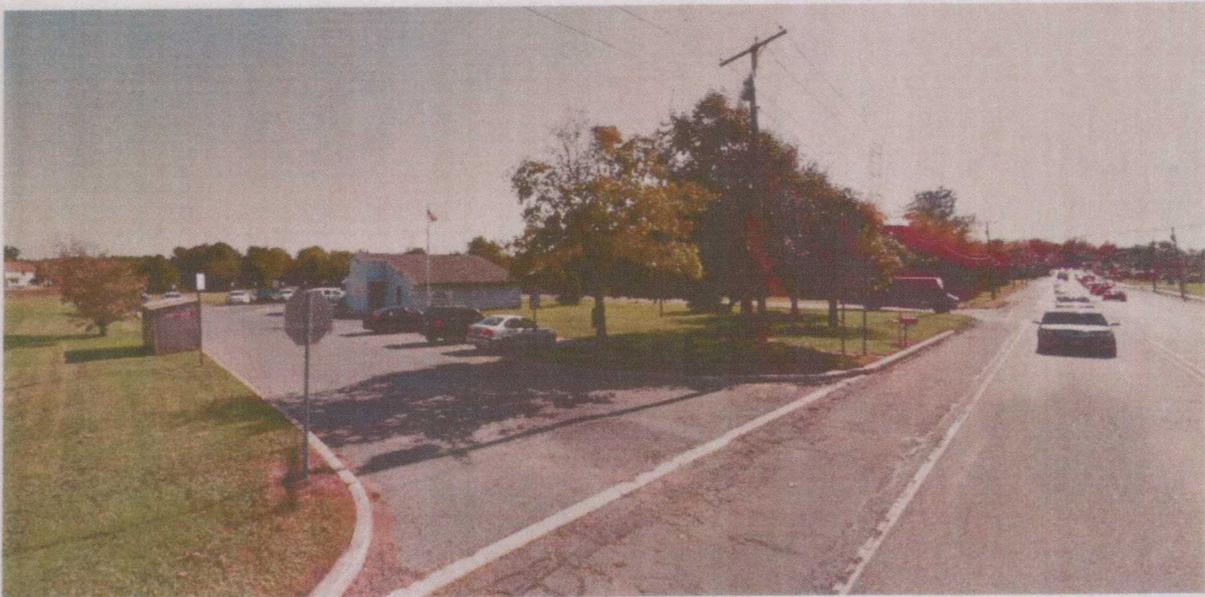
Figure 12. Street View of Block 38.01, Lot 21

- The Sergeants Office currently serves as both the office and interview room.
- The Arrestee area is an undersized, non-secured common area; within the past two years, two escapees have run out the rear of the station.
- The structure does not provide sufficient space during shift changes.

- Arrestee area is severely limited; no more than two prisoners can be held at a time. Additional arrestees have to be kept on chairs in an office or on patrol side of work station. Further, there is no place for a juvenile to be kept securely if and adult arrestee is present.
- Structural deficiency examples: inadequate ventilation, no separate area for IT equipment, the electrical generator is not up to current standards.

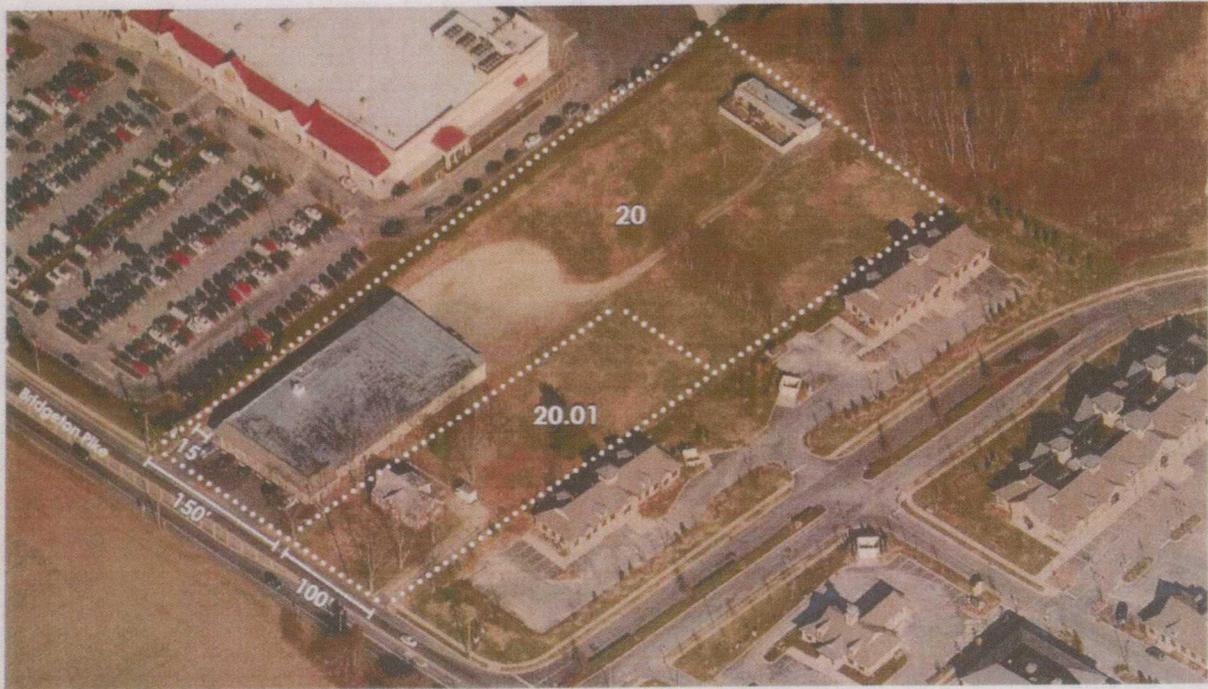
Figure 15. Bird's Eye View of Block 57, Lots 20 & 20.01

The single-entry point to the rear of the property presents another on-site faulty configuration condition. The narrow gravel road in the side yard is approximately 15 feet wide, severely limiting the access to the rear of the property. As can be seen in Figure 15, behind the structure, access to the rear of the property is through ad-hoc paths, and a large area of the Lot currently sits unused.

As shown in Figure 15, the ingress and egress point to Lot 20 is along Bridgeton Pike. As a result, vehicles parked in front of the structure have to back out toward the busy roadway. This creates a public safety hazard for those attempting to enter and exit the Lot, and has possible adverse effects to the vehicular traffic flow along the roadway.

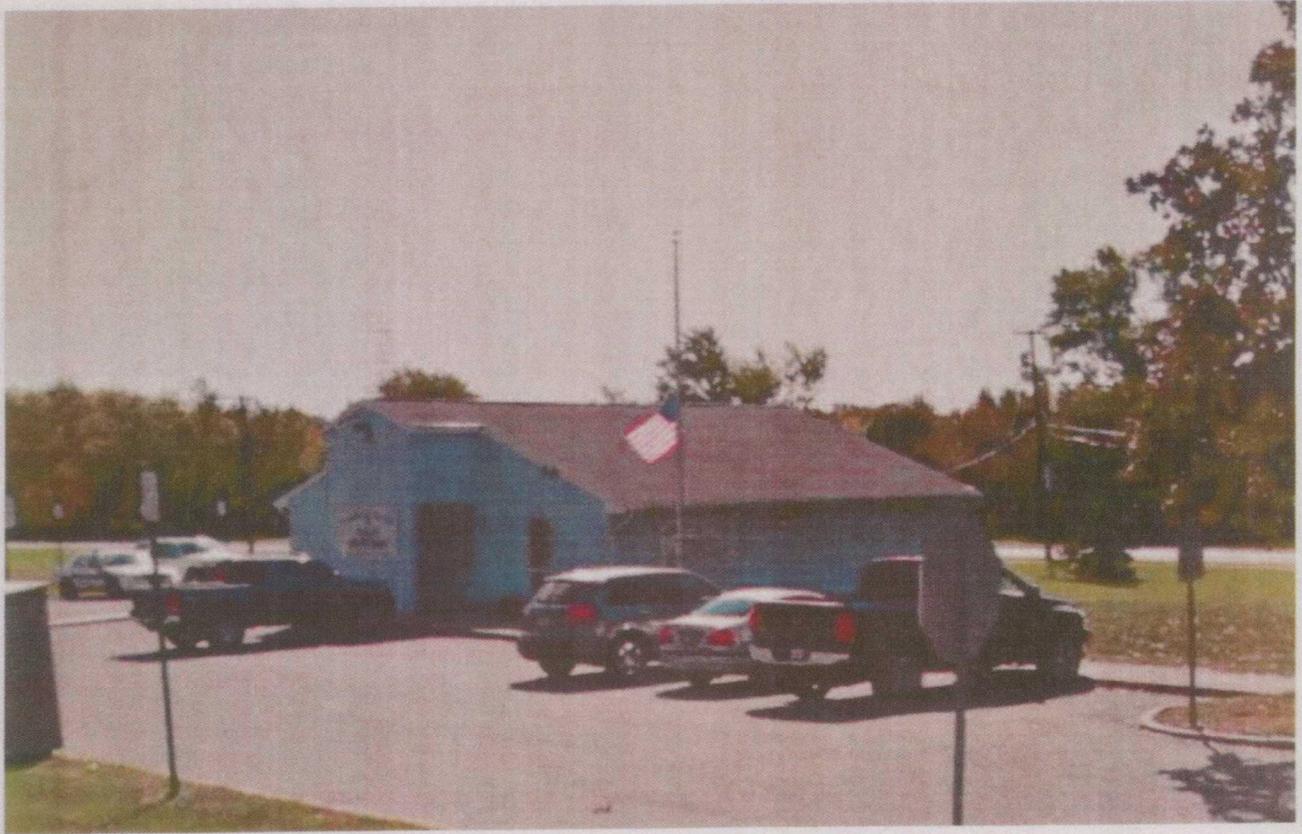
Existing Police Station

1. Water Pipes freeze in cold weather.
2. The Generator is operational, but not up to code and approximately 10 years old. (600.00 in repairs 2015)
3. The building required a new AC Unit and Heater in 2015 due to failures.
4. Amount of work and required storage thereof is overtaking the building as there is little storage unless outside in trailer which runs the risk of being damaged by mold/mildew.
